## 1. Technology Existing Conditions/**Telecommunications Infrastructure (cont.)**

### Rooms/Spaces – Telecommunications Rooms (TRs)

### Telecommunications Rooms (TRs): District-wide Observations

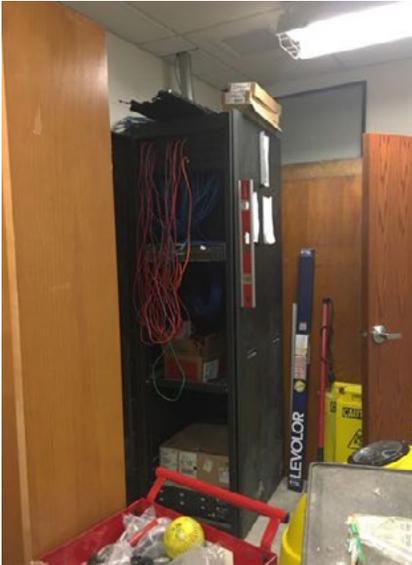
*TR-3 (ES Rm. 248) is in good condition but needs to be devoted to IT equipment. There would be adequate space for another rack.*

4. **Intermediate TR-3 (ES Rm. 248 - Storage)** is in **good condition** but does need a number of improvements including increased security, installation of UPS and grounding at the rack, and removal of the drop ceiling to improve air circulation and equipment cooling.

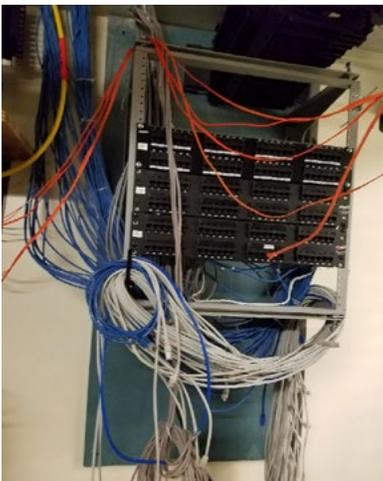
*Abandoned legacy cable in ITR-2 (HS Rm. 104).*

3. **Intermediate TR-2 (HS Rm. 104 - Storage)** is in a shared, unsecured space with no air conditioning or grounding, and improper horizontal and vertical cable management. The ITR-2 is in poor condition and requires a complete renovation to meet all TR performance criteria as outlined on pp. 20 – 21.

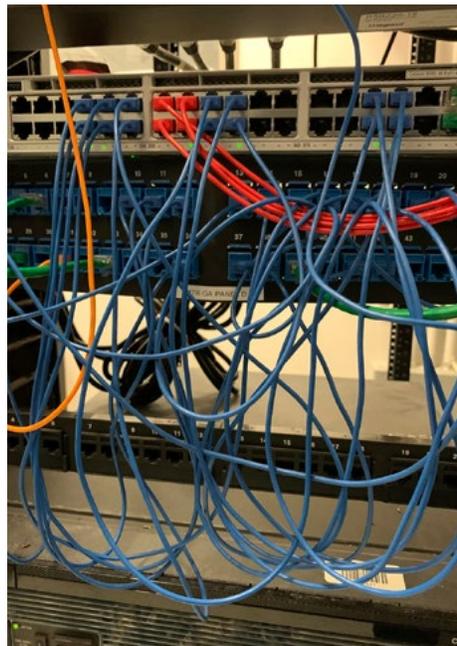
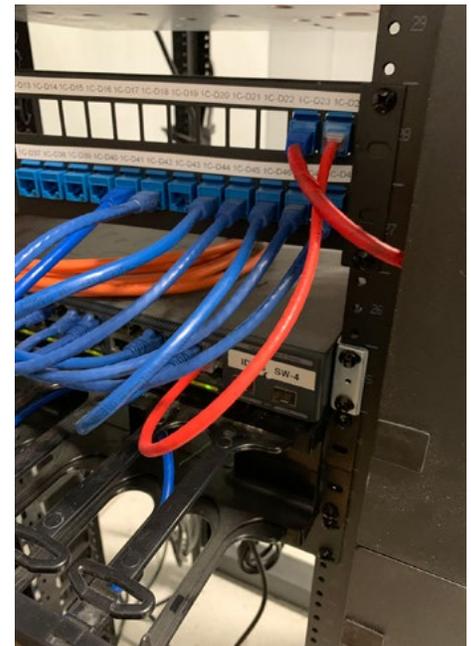
2. **Main TR (MS Rm. 154 - Server Room)** was constructed during the '19/'20 Capital Improvement Project and is in **very good condition**. However, it does require eliminating non-IT items and water threats, improving security, and implementing a regular PM schedule to maintain peak performance conditions.

*At left, one rack in the MTR (MS Rm. 154) show signs of "cable creep" in patch panels and server cables. At right, another rack in the same TR has correctly sized patch cords are neatly installed in machine-labeled ports.*
