Comprehensive Technology Report and Plan

- Technology Condition Survey Report
- Telecommunications Room Master Plan
- Comprehensive Technology Plan Roadmap

Prepared for Anytown Central School District

Presented by Archi-Technology LLC

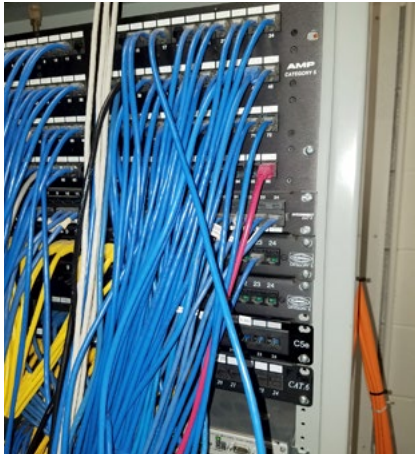
ES and MS horizontal cable management does not meet standards.

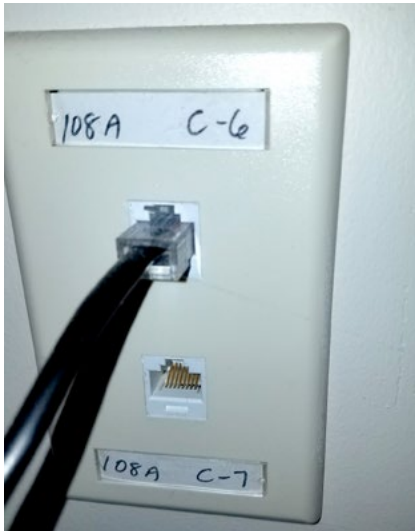
Typical ES and MS cabling with non-conforming labeling

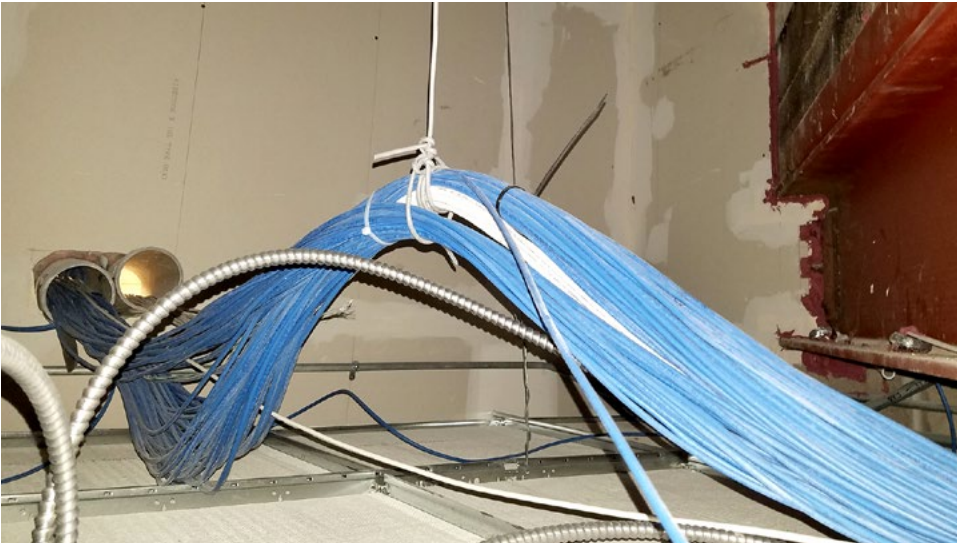
- 3. Most horizontal cabling is installed in the cable tray in the corridors. In the ES and HS, cabling is typically unsupported between the primary pathway (cable tray) and the secondary pathway to the telecommunications outlet.

Example of improperly supported horizontal cable in the High School.

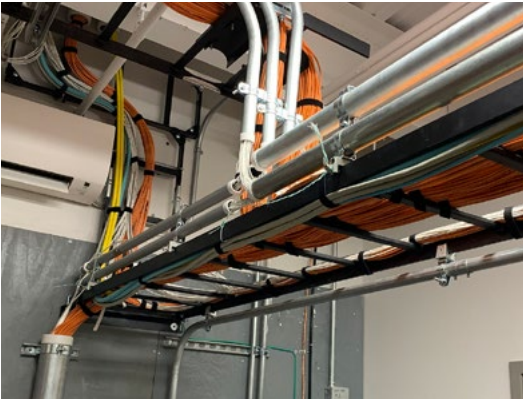
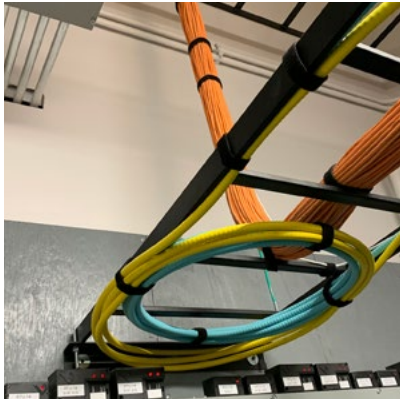
Ladder racking correctly installed and deployed in the Middle School MTR Rm. 154.

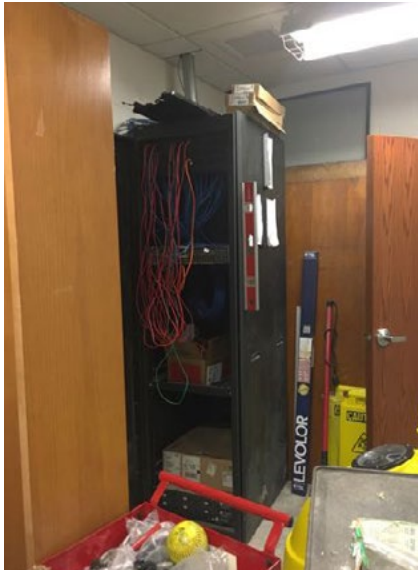
TR-3 (ES Rm. 248) is in good condition but needs to be devoted to IT equipment. There would be adequate space for another rack.

- 4. **Intermediate TR-3 (ES Rm. 248 - Storage)** is in **good condition** but does need a number of improvements including increased security, installation of UPS and grounding at the rack, and removal of the drop ceiling to improve air circulation and equipment cooling.

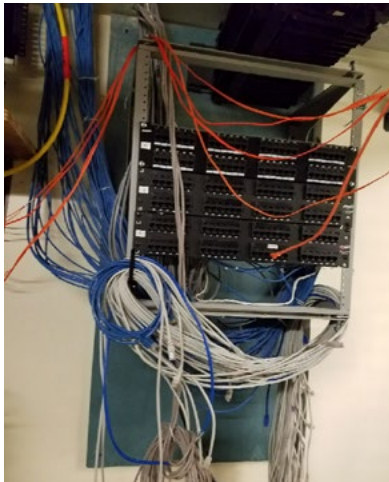
Abandoned legacy cable in ITR-2 (HS Rm. 104).

- 3. **Intermediate TR-2 (HS Rm. 104 - Storage)** is in a shared, unsecured space with no air conditioning or grounding, and improper horizontal and vertical cable management. The ITR-2 is in poor condition and requires a complete renovation to meet all TR performance criteria as outlined on pp. 20 – 21.

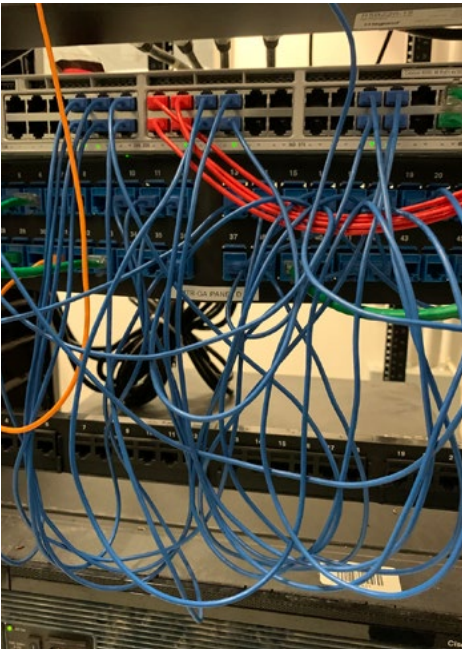
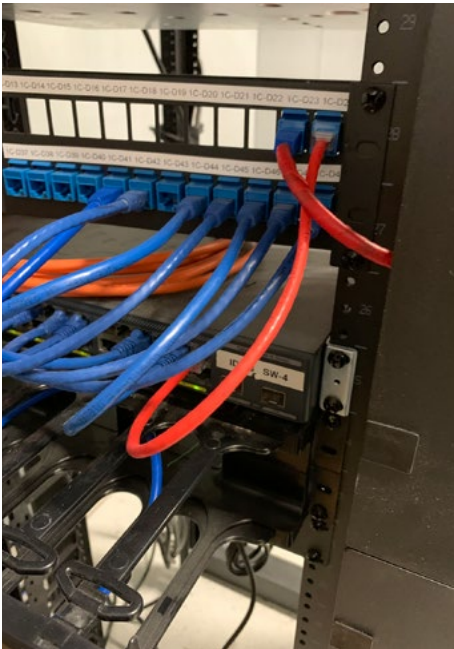
At left, one rack in the MTR (MS Rm. 154) show signs of “cable creep” in patch panels and server cables. At right, another rack in the same TR has correctly sized patch cords are neatly installed in machine-labeled ports.

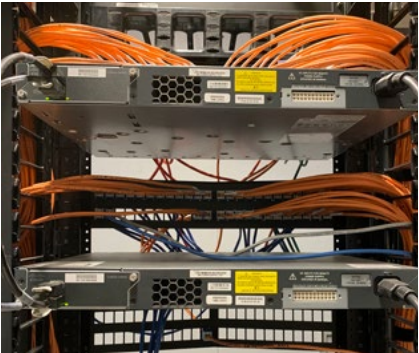
The rack in the MTR (MS Rm. 154) includes properly installed cable lengths and management.

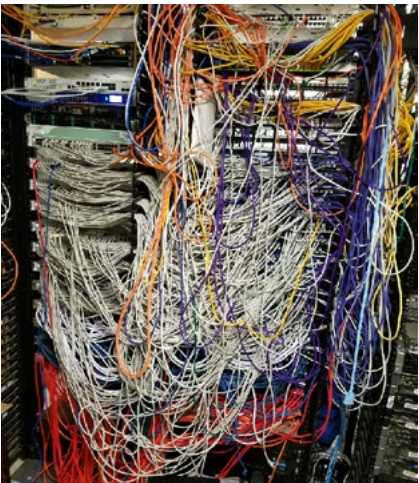
Extremely poor vertical cable management at the rack in ITR-2 (HS Rm. 104).

- 7. There is no grounding or bonding infrastructure.
- 8. No UPS was observed in the space.
- 9. Overhead, vertical and horizontal cable management do not meet industry standards. Patch cords are excessive lengths that inhibit servicing.

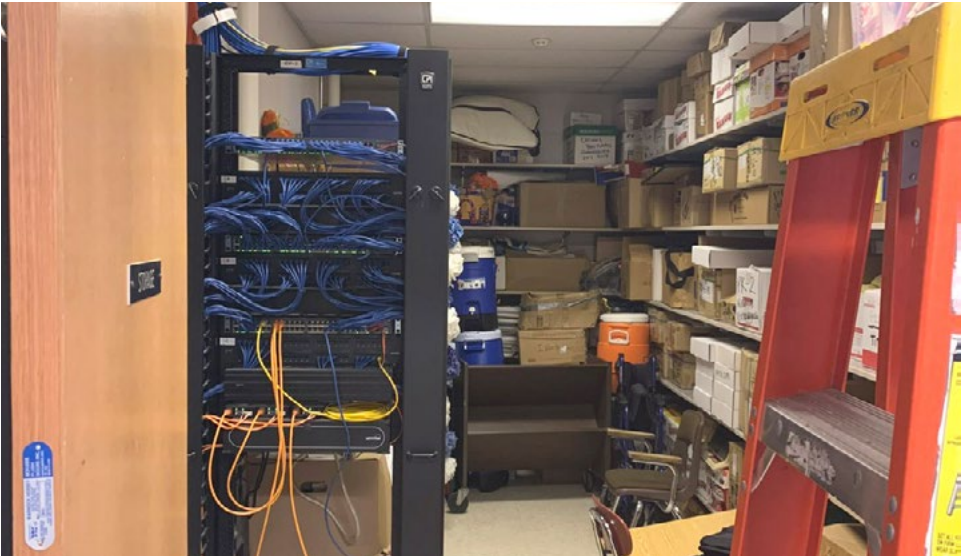
Unsecured, shared space with office supplies storage in ITR-2 (HS Rm. 104) with drop ceiling and partial carpet (not visible in photo).

ITR-2 - Storage Room: HS Rm. 104 [Rating 1.3/4.0]

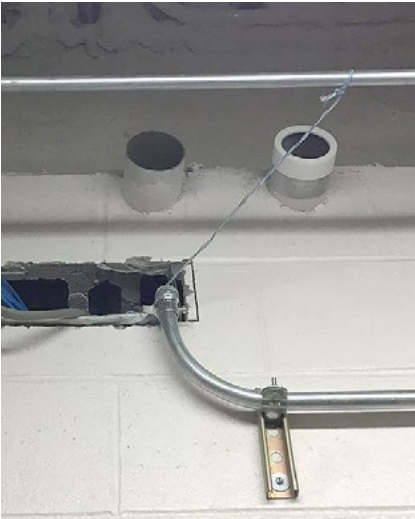
Firestop is needed in the conduits in ITR-3 (ES Rm. 248A).

8. The conduits into the room are within capacity limits but are not firestopped.
 9. The rack outlet is connected to the district's emergency power generator and a rack-mounted UPS is installed.

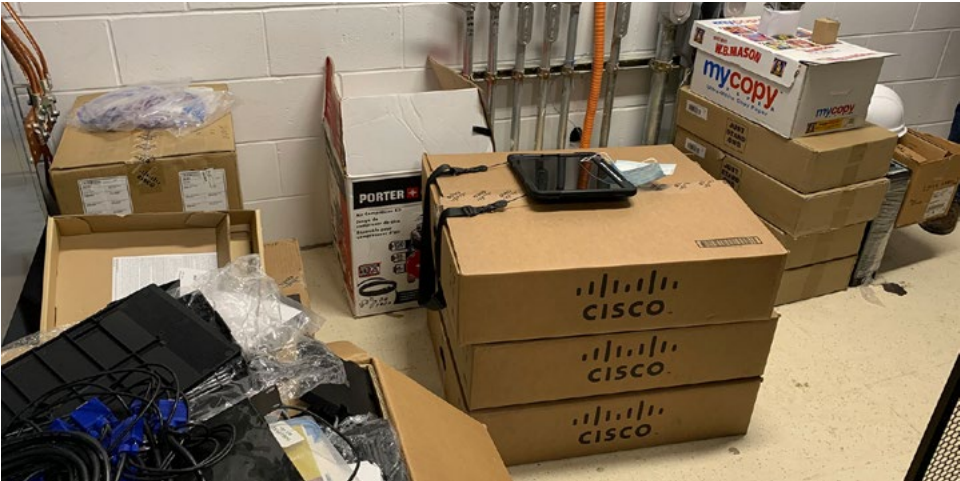
End-of-life and unused IT equipment in ITR-3 (ES Rm. 248A).

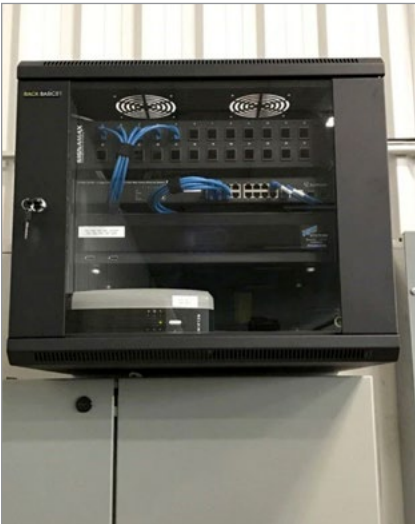
The wall-mounted IT equipment cabinet in the Computer Lab (MS Rm. 143) is in excellent condition.

- Wall Mounted Equipment Cabinet
Computer Lab: MS Rm. 143**
1. This locked IT wall-mounted equipment cabinet connects the room's computers to the district's wired network.
 2. The cabinet has (48) ports including (14) open ports.
 3. Overall, the cabinet is in excellent shape with good connections and proper labeling.
 4. The wall-mounted cabinet was equipped with a rack mounted UPS. The UPS has a limited run time.
 5. The cabinet is located in a larger space. The heat load produced by the cabinet equipment is limited and the heat typically dissipates.

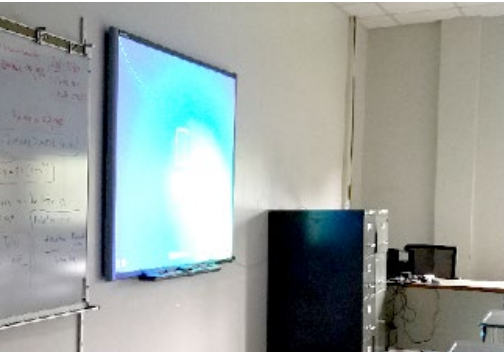
- Classroom Systems**
1. The typical classroom has a ceiling mounted projector and a 64" smartboard.
 - a. The SB660 Series has a posted end-of-support date of 9/1/20. The HS boards are considered undersized when using current display-size calculations.
 - b. Projectors are typically connected to the network. The Epson Powerlite projectors are no longer in production.

Typical MS-HS Classroom AV system

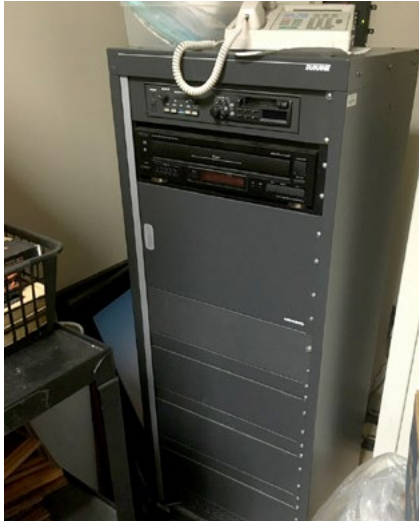
PA Systems	<div><div><div>1. The Acme PA System is more than 15 years old and is nearing end-of-life. It is an analog system with hard-wired devices that does not integrate with the rest of the District's IP platform.</div><div>2. In the event of a power failure, the small UPS will support the system for less than 5 minutes at full load. The system is not connected to a generator.</div><div>3. Announcements cannot be made through the VoIP system telephones.</div><div>4. The system does not auto-mute the PA systems in the gymnasium, or auditorium in the event of a building-wide page.</div><div>5. The PA system does not control the time tones nor synchronize with the Master Clock system.</div></div><div>

<p><i>Building PA system nearing end-of-life.</i></p></div></div>
-------------------	--

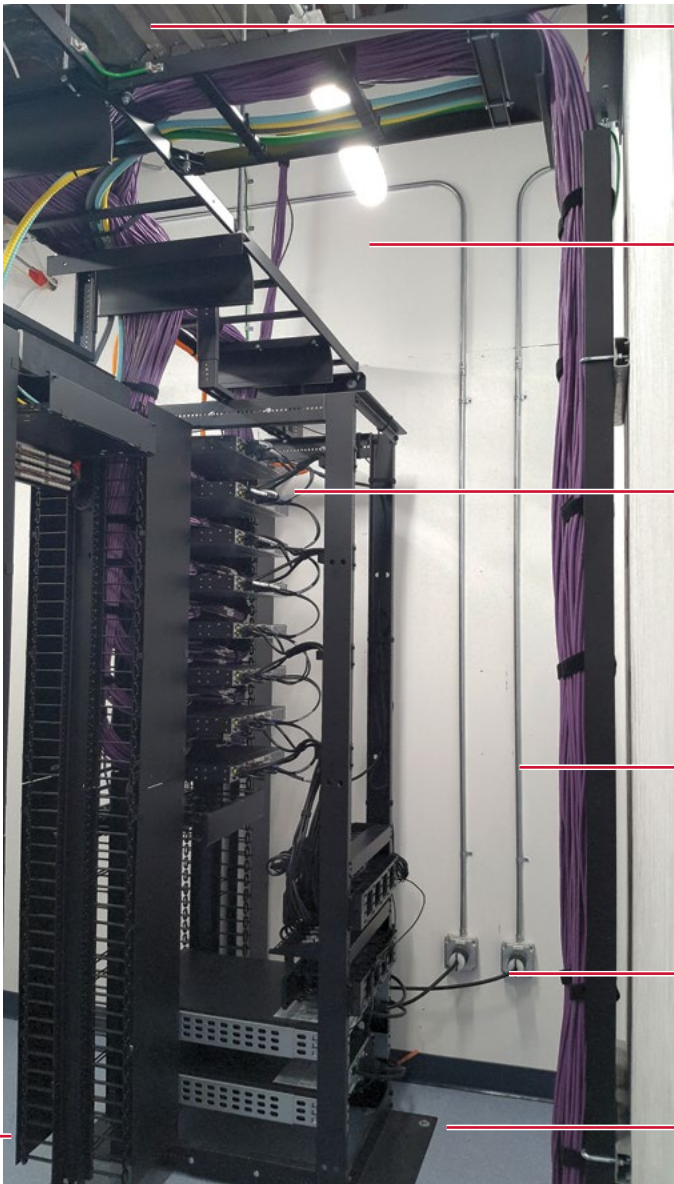
[6] **UPS/EM Power.** Uninterruptible Power Supply and/or Emergency Power source.

[1] **Room size.** Allows rack front and back clearances.

[12] **Ceiling.** Open to deck with 10' minimum height

[8] **Division 27 fit out.** Overhead (horizontal) cable management and fire-resistant plywood wall. Overhead ladder racks reduce strain on cabling and improve performance.
