Preface: Telecom Rooms (TRs)

13 factors that influence Telecom Room performance

13-Point Checklist for IT Equipment Spaces

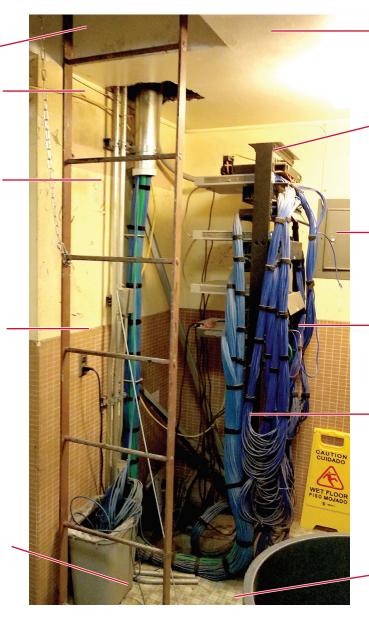
What makes a poor TR bad...

[2] Overhead utility pipes leave racks susceptible to damage from leaks/bursts.

[11] Poor room construction with no deck access and poor cable penetrations.

[3] Location lacks direct hallway access and the Serving Zone distance is greater than 300'.

[8] Lack of grounding infrastructure increases risk of electrical shortage and equipment damage.

[4] Unsecured, shared **space** creates a life safety and security risk as well as causing possible accidental damage.

[7] Lack of Uninterruptible Power Supply (UPS) or emergency power source creates life safety risks during power outages, and reduces equipment lifespan due to a

[2] Dirty, dusty environment increases risk of operating

lack of conditioned power.

issues with rack components and reduces equipment lifespan.

[13] Hard ceiling inhibits inspection and serviceability, and limits airflow while trapping heat.

[9] Overhead cable management is lacking putting cables at risk of damage.

[6] No dedicated and redundant power. Both a dedicated circuit and a power outlet from a building generator are needed.

[10] No cable management or correct termination at the rack can cause operational issues and makes troubleshooting difficult

[1] Room size and inadequate rack clearances inhibit serviceability.

[5] No environmental controls increases risk of equipment overheating.

[12] Floor tile is not antistatic increasing risk of Electro-Static Discharge.

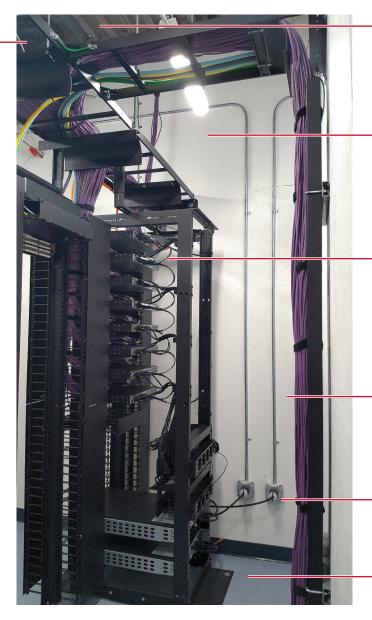
...and a good TR great.

[1] Room size

allows rack front and back clearances.

[2] Water risk. No nearby utility pipes, drains, or custodial slop sinks.

[3] Location provides direct hallway access and is centrally located in the Serving Zone.

[4] Security. Secure or dedicated space, or locked cabinet, with IP camera coverage and access control.

[5] Environmental control. AC and exhaust fan with independent controls in same room.

[8] Grounding infrastructure including a Telecommunications Grounding Busbar (TGB) is installed.

[7] UPS/EM Power. Uninterruptible Power Supply and/or Emergency Power source.

[13] Ceiling. Open to deck with 10' minimum height

[9] Overhead cable management and fireresistant plywood wall are installed. Overhead ladder racks reduce strain on cabling and improve performance.

[10] Cable Termination and Management. Adequate racks/cabinets and cable management. Horizontal and vertical management systems are in the rack to reduce strain on cabling and improve performance.

[11] Room construction.

Walls extend to deck. Cable penetrations are compliant and sealed (fire stopped).

[6] Power. Dedicated circuit with circuit ID labels from two different panels.

[12] VCT flooring. Anti-static tile.
